# Manhole Inspection Summary

Manhole # S23A\_\_023MH

Insp Date: **7/27/07 10:09 AM**

**Location** Address: **705 CALHOUN ST**

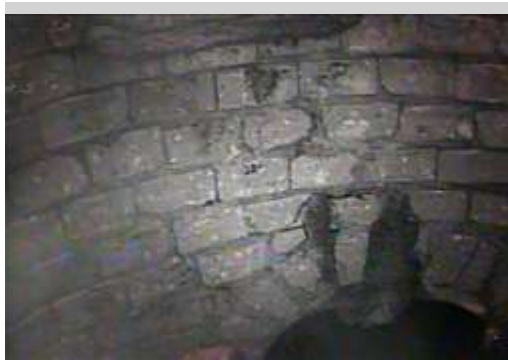
Defect 3

Infiltration: ☐ None ☐ Joint ☐ Cracks ☐ Mortar ☐ Roots ☒ **Wall**

INFILTRATION OF BARREL ABOVE O12 PIPE

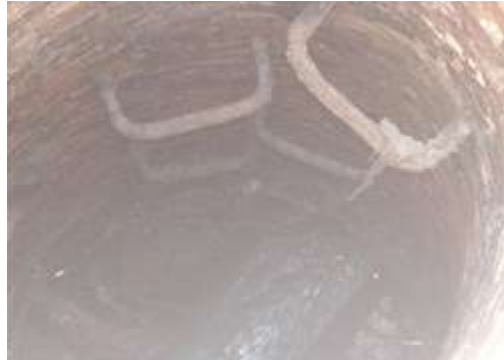
Defect 2

☒ **Evidence Of Surcharge** Depth: **6** (ft.) ☐ Active Surcharge Present

SURCHARGE EVIDENCE ON STEPS

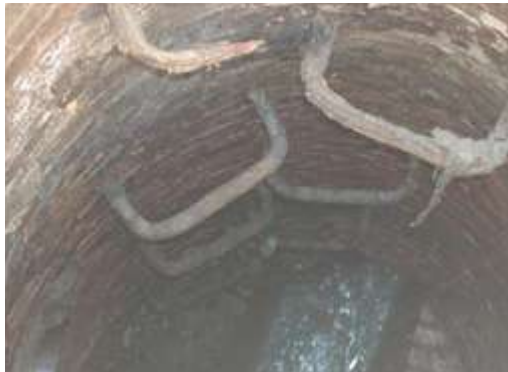
Defect 1

Count: **7** Missing: **2** ☒ **Corroded**

MISSING AND CORRODED STEP

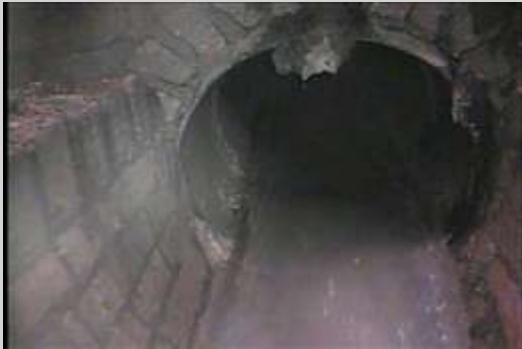
12 O'Clock Outflow

Pipe Height: **18** (in.) Rod and Bar (Angled)  
Pipe Material: **Clay** ☐ Pipe Lined  
Invert Depth: **16.08** (ft.) Flow Characteristics: **Fast**  
Deposits: ☒ None ☐ Mud ☐ Sludge ☐ Debris ☐ Grease  
Silt Depth: (in.) Deposits Extent:  
Infiltration: **None** Pipe Seal Cond: **Sound**

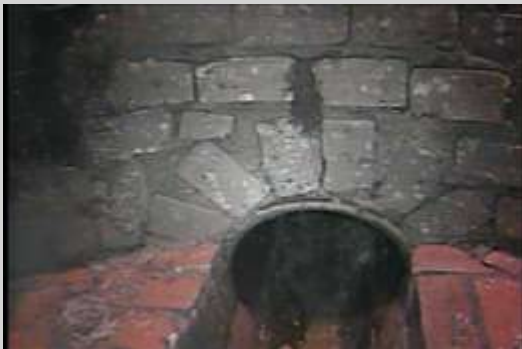
3 O'Clock Inflow

Pipe Height: **8.4** (in.) Rod and Bar (Angled)  
Pipe Material: **Clay** ☐ Pipe Lined  
Invert Depth: **15.02** (ft.) Flow Characteristics: **Slow**  
Deposits: ☒ None ☐ Mud ☐ Sludge ☐ Debris ☐ Grease  
Silt Depth: (in.) Deposits Extent:  
Infiltration: **None** Pipe Seal Cond: **Sound**

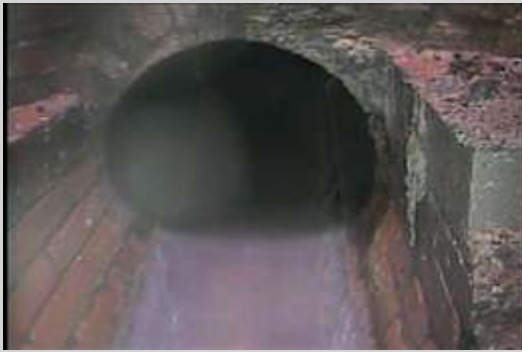
6 O'Clock Inflow

Pipe Height: **18** (in.) Rod and Bar (Angled)

Invert Depth: **15.80** (ft.) Flow Characteristics: **Fast**

Infiltration: **None** Pipe Seal Cond: **Sound**

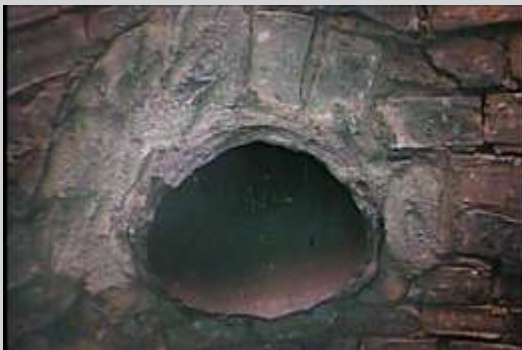
9 O'Clock Inflow

INFILTRATION OF BARREL ABOVE O12  
PIPE

Infiltration: **None** Pipe Seal Cond: **Sound**

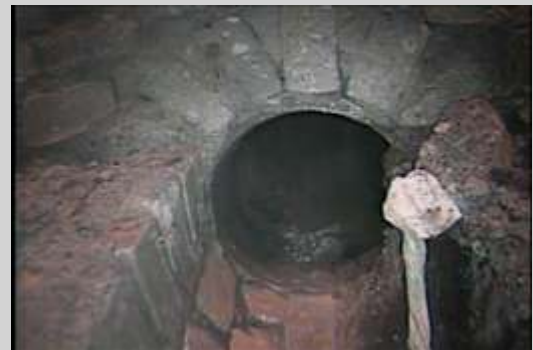
Drop In @ 9 O'Clock

INFILTRATION OF BARREL ABOVE O12  
PIPE

Drop: **Outside** Rod and Bar

Drop Condition: **Open**
